Esperanza Fire  
Accident Investigation  
Factual Report

Riverside County, California  
October 26, 2006

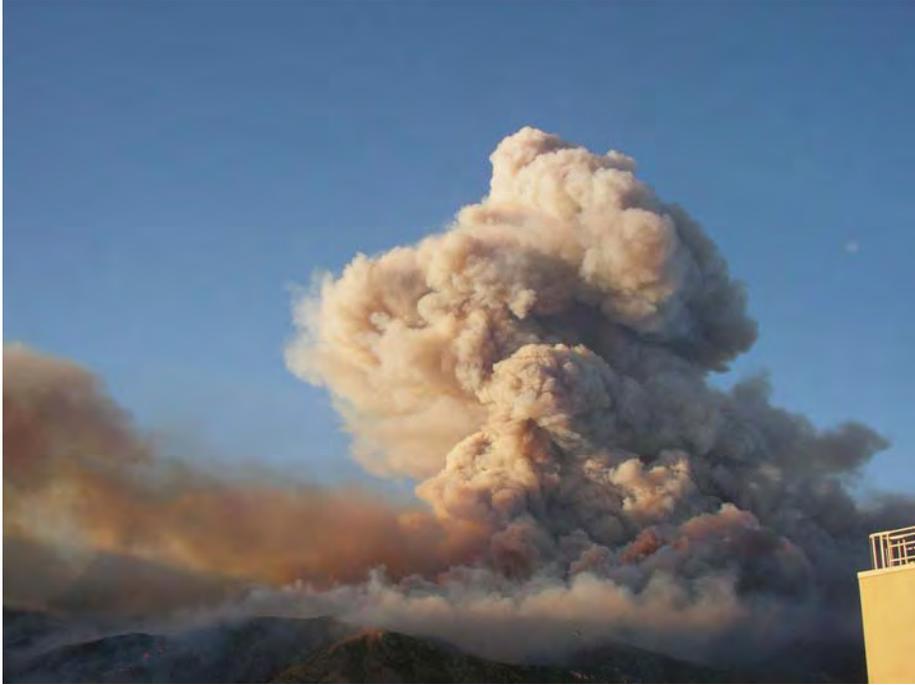
Exhibit 2. Fire breaking through the inversion at 7:30 a.m. PDT  
*Courtesy of Guy McCarthy/The Sun, San Bernardino County Newspaper*

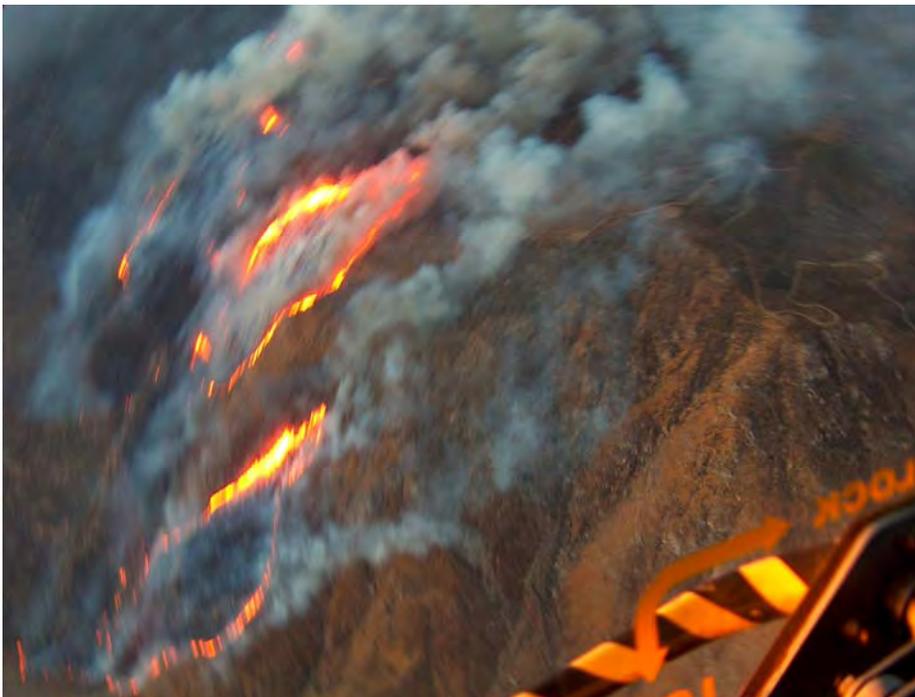
Exhibit 3. Aerial view of spot fires below the Accident Site  
at approximately 7:10 a.m. PDT

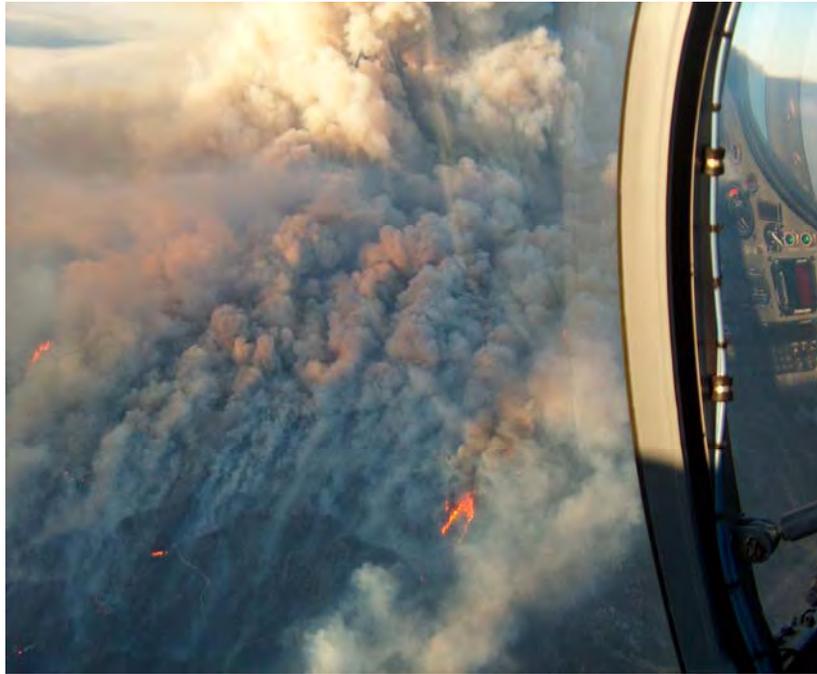
Exhibit 4. Aerial view of the fire run at approximately 7:14 a.m. PDT

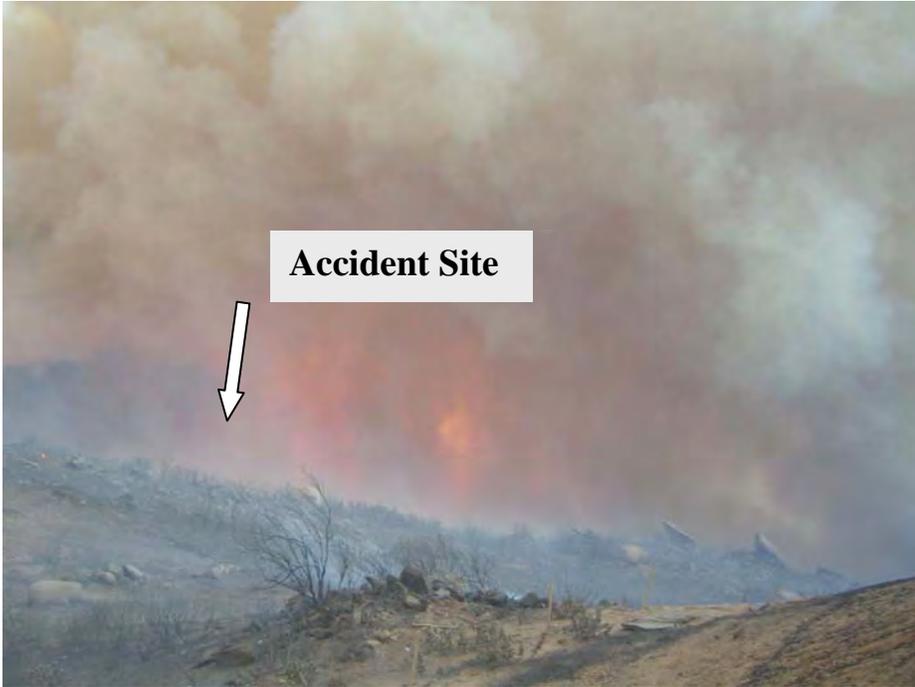
Exhibit 12. Fire run looking towards the Accident Site from the Tile House.

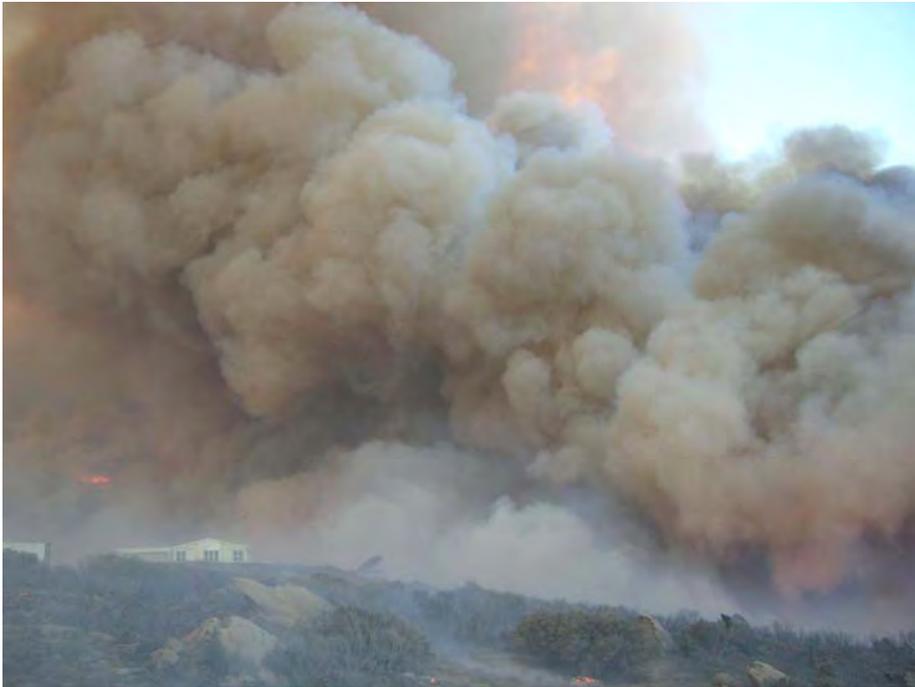
Exhibit 13. Fire run looking just above the Accident Site from the Tile House.

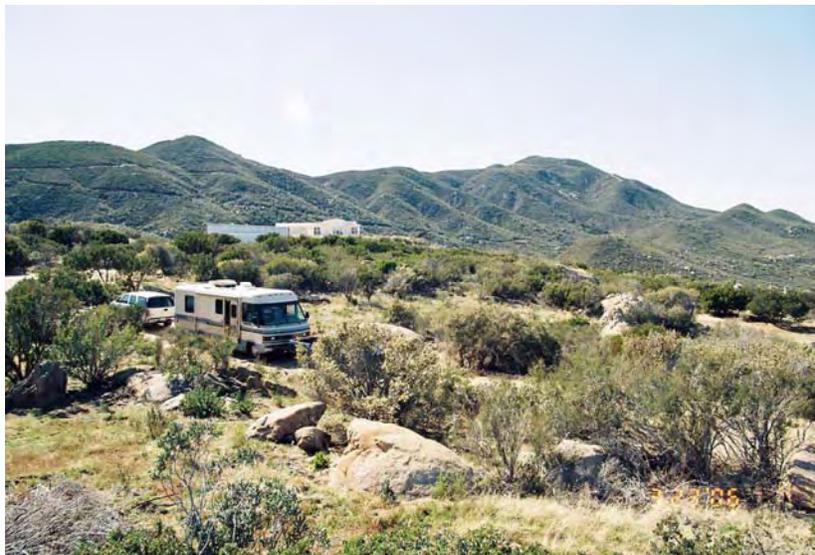
Fire Behavior Analysis Figure 1. Fuel loading before Esperanza Fire

Fuels in the area historically average a growth density of 1 to 1.5 acre tons per year. The age class of fuel in the area was 17 years which is considered mature vegetation. The fuel loading is estimated to be 20 to 25 tons per acre. The average fuel height was five feet with areas of 8 foot intermix of Manzanita and Mountain Mahogany throughout. Overall, fuels were very volatile and had latent potential for significant energy release due to age and tons per area.

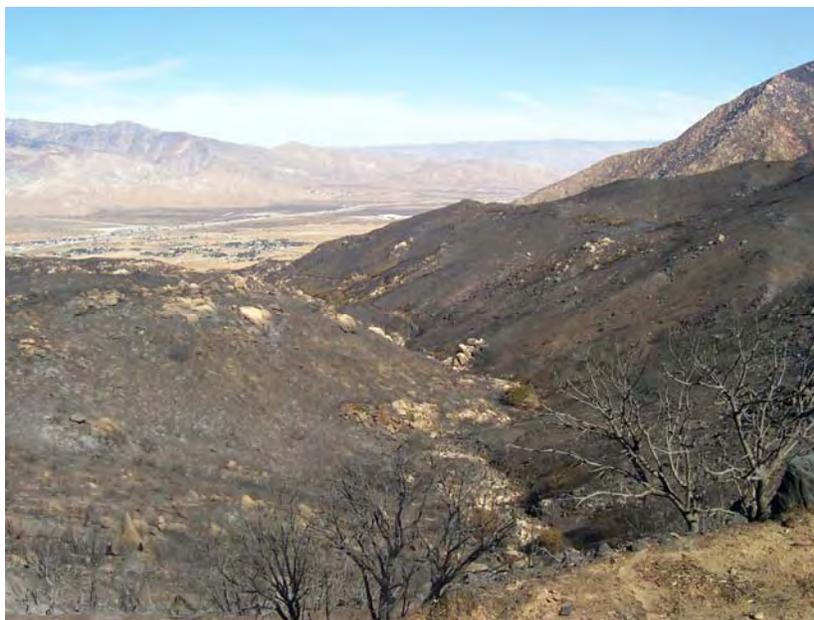
Fire Behavior Analysis Figure 2. Fuel loading after Esperanza Fire

Fuel moisture content was influenced by the normal summer season lows which occur between the months of September and December. Fuels had become increasingly dry and flammable. The old growth plants had developed fine to larger dead branches within which were kindling dry and able to promote rapid and large fire growth. Live fuel moistures were estimated at <60 percent in Chamise and Sage Brush. Manzanita and Mountain Mahogany which are larger broadleaf shrubs held a slightly higher value of <75 percent. The dead fuel moisture contents in the 1 and 10 hour timelag fuels were at an equal value of 3 percent at the time of the fire start. Based on on-site and predicted weather, the probability of ignition given these fuel moistures is between 80 percent and 100 percent. Fire consumption in 1, 10, and 100 hour fuels would achieve 100 percent and consumption in the live fuels would average 90 percent.

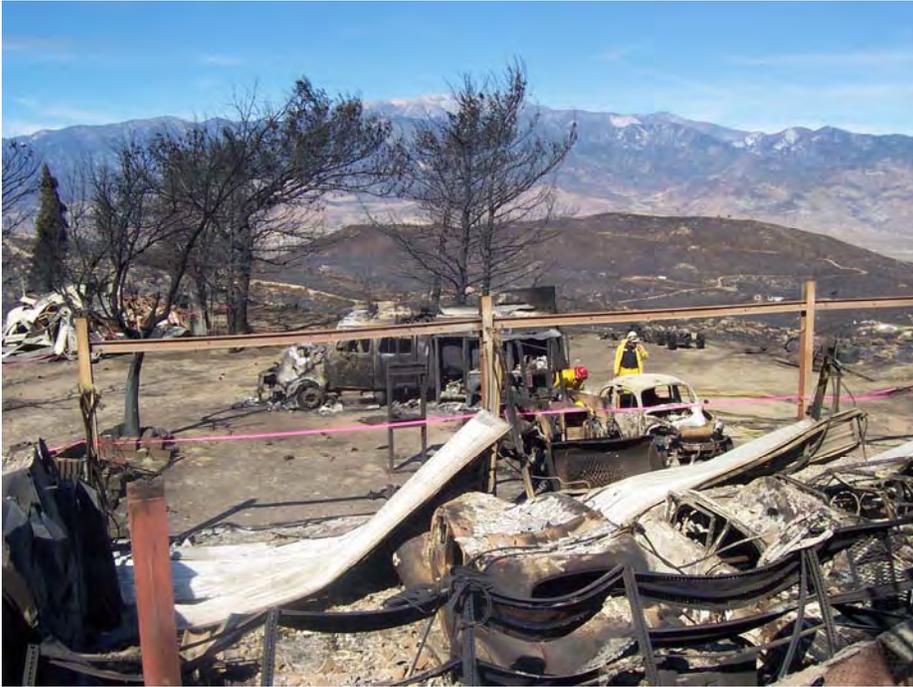
Fire Behavior Analysis Figure 3. Scorch Height

On-site accounts and scientific modeling confirmed a head fire run in excess of 30 miles an hour and winds exceeded 50 mph at the accident site. Burn indicators found in the trees at the accident site indicate the flame height remained within 15 feet of the ground.

This is indicative of the wind remaining parallel with the ground and increasing in speed near the ground as the wind climbed the slope extending to the ridgeline.
