Esperanza Fire  
Accident Investigation  
Factual Report

Riverside County, California  
October 26, 2006

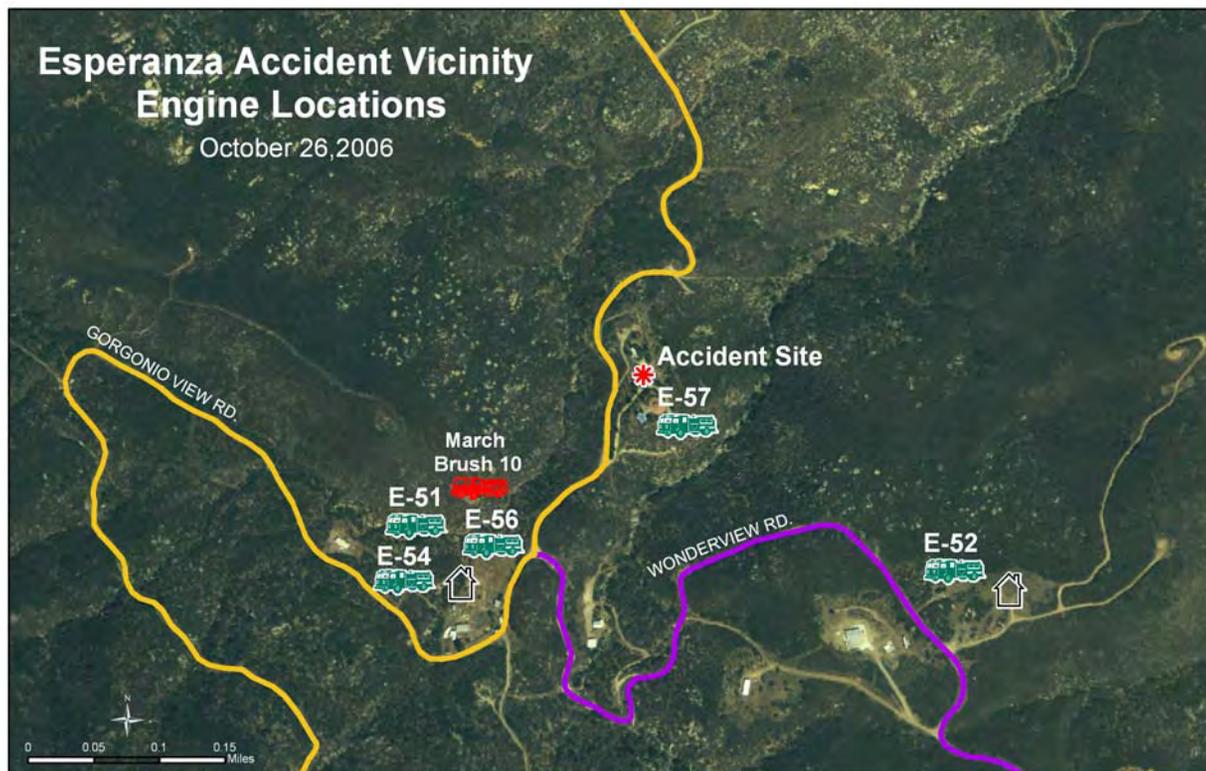
At approximately 6:20 a.m., Engines 51, 54, 56 and MB-10 met Branch II along Gorgonio View Road and were directed to stay at 15975 Gorgonio View Road (Doublewide) where they now began to quickly size-up the structure and make defensive plans. (See Figure 6, Page 12 – Fire engine locations at the Esperanza Fire Accident Site Map)

Figure 6. Fire engine locations at the Esperanza Fire Accident Site Map

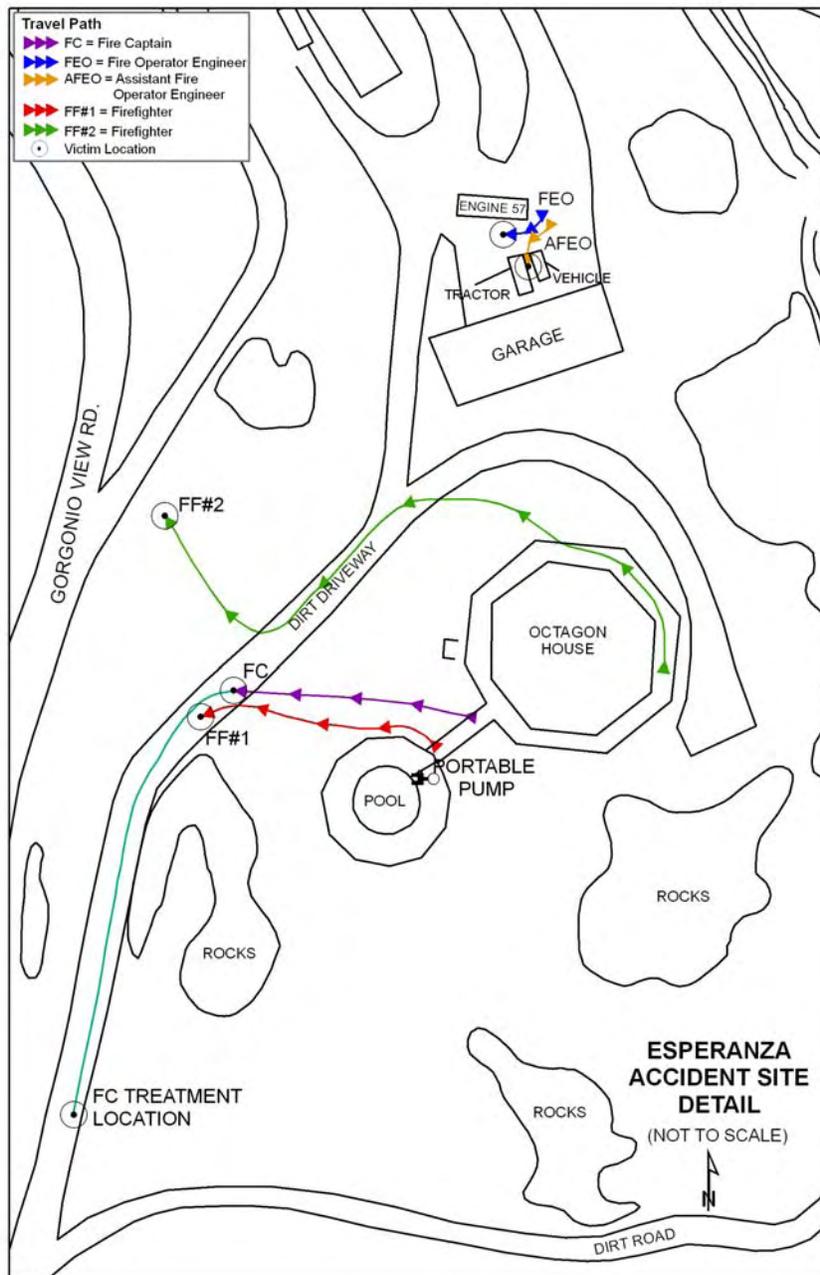
Attempts by Engine 52 to contact Engine 57 went unanswered at approximately 7:15 a.m. At approximately 7:57 a.m., the heat and smoke had diminished enough for Engine 51 and 52 Captains to work their way into Engine 57's location to discover the burnover. Immediate attempts by Engine 52 Captain to make an emergency call for assistance on the assigned fire command channel were unsuccessful, so he switched over to a Forest Service radio frequency and made contact with the Federal Interagency Communications Center (FICC). Following some initial confusion at the ICP over what was happening and where, the first agency medevac mission was activated with United States Forest Service Helicopter 535. Due to its Type III status and high winds, Helicopter 535 was unable to meet the mission. CAL FIRE Helicopter 301, a Type II, was able to land near the accident site at 8:22 a.m. to transport one burn victim. A second Type II helicopter, CAL FIRE Helicopter 305, then transported the second burn victim at 8:35 a.m. The bodies of the three deceased firefighters were removed from the site at approximately 7:09 p.m. PDT. (See Figure 7, Page 13, Fire Engine 57 personnel travel paths)

Figure 7. Fire Engine 57 personnel travel paths.

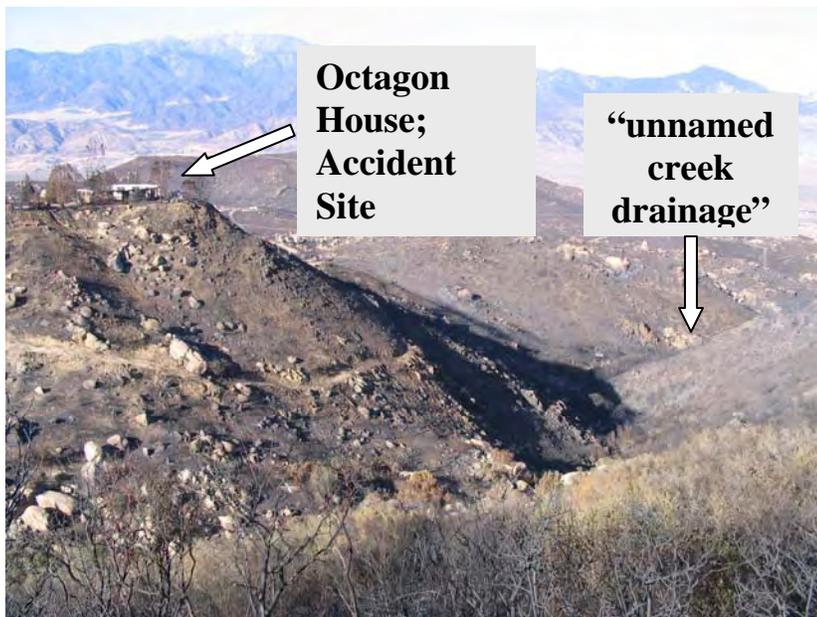
Exhibit 5. Accident Site; looking north from Wonderview Road between the Tile House and Accident Site.

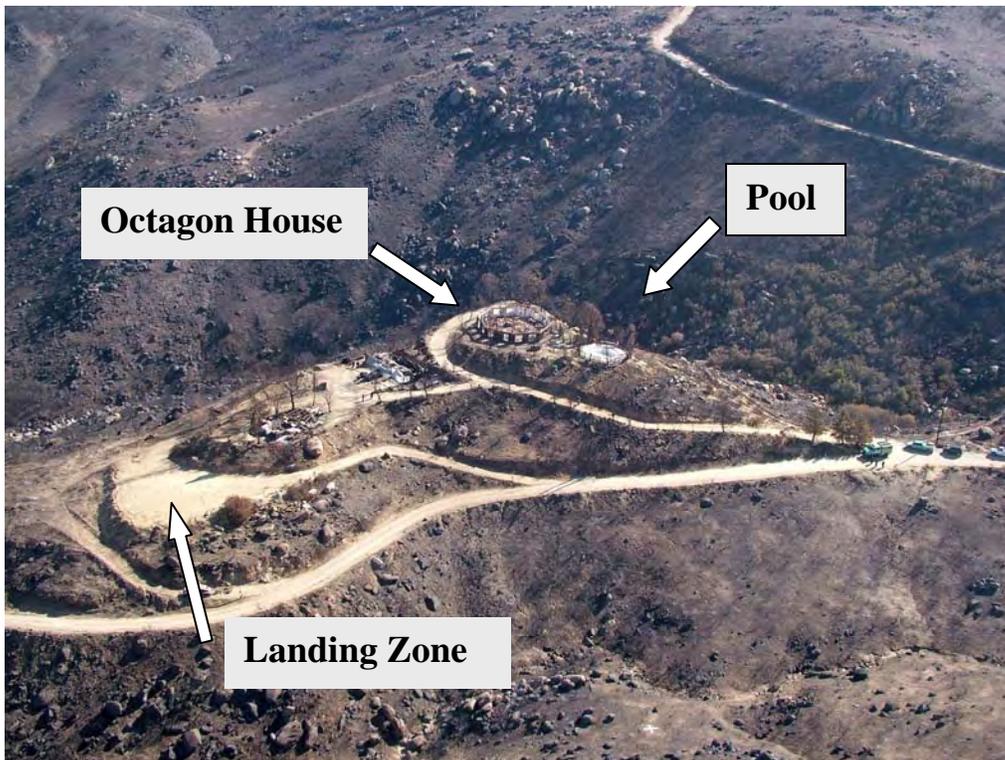
Exhibit 10. Accident Site overview.

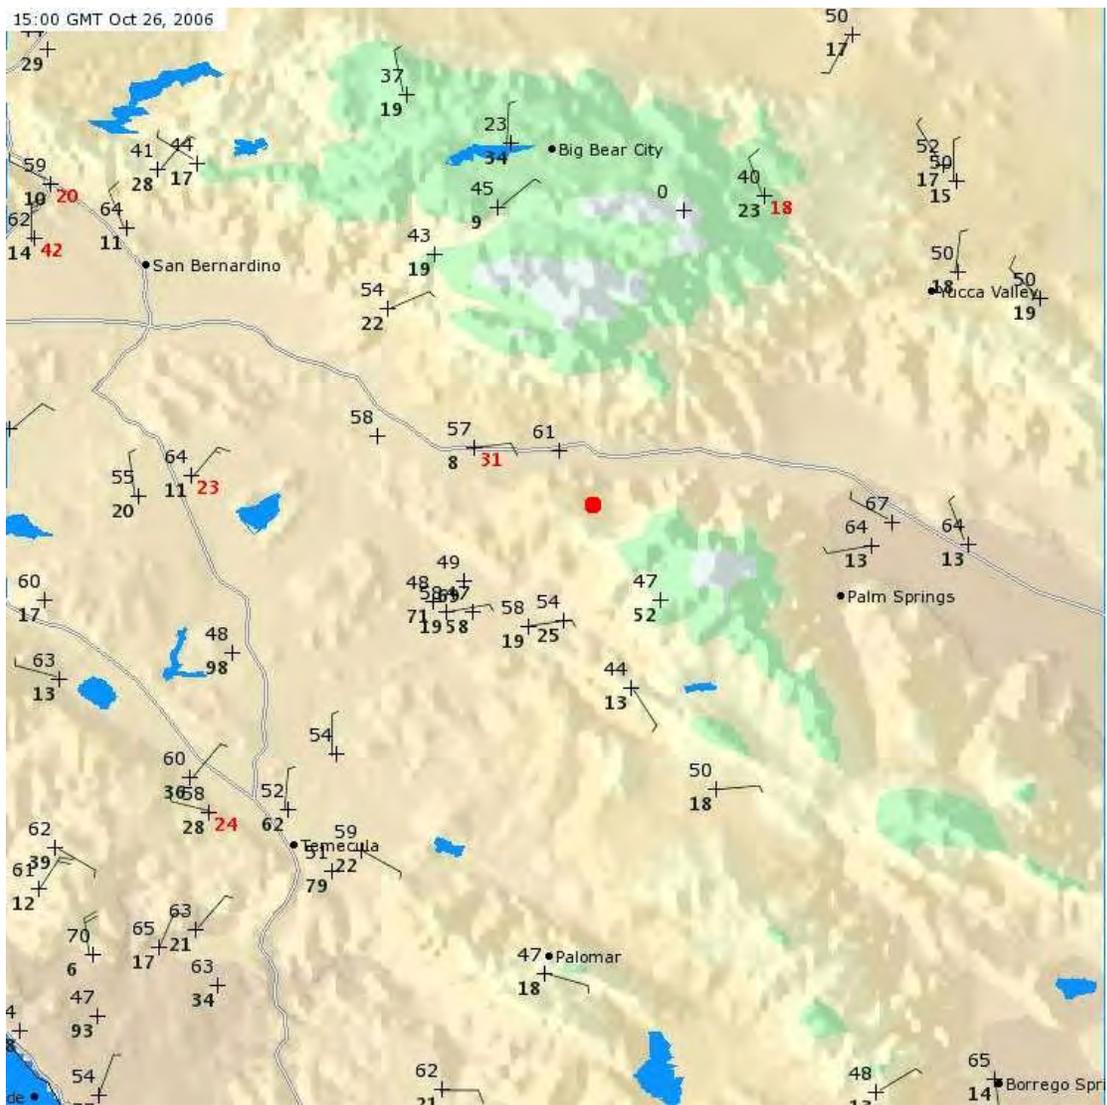
The Santa Ana Winds develop due to the cooler air over the Mohave Desert having higher pressure than the warmer air to the west over the greater Los Angeles basin. Fire Weather Figure 1 shows the terrain and surface weather data over southern California at 7:00 a.m. PDT on October 26. This map shows how cold air pooling over the Mohave Desert is blocked by the San Bernardino and San Jacinto Mountains. San Gorgonio Pass is aligned east-west constraining the winds to blow only east or west. At 7:00 a.m., the Santa Ana Winds have driven westward through most, but not all of the greater Los Angeles basin. A few RAWS in the lower left portion of the map still show high relative humidities indicating the dry Santa Ana air has not penetrated into those areas. Also

**Fire Weather Figure 1 - 15Z October 26 (7:00 am PDT) Surface data over southern California showing Temperature, Relative Humidity, wind direction and speed, and wind gusts in red. The accident site is near the red dot in the middle of the map. The Beaumont RAWS is located northwest of the accident site showing a temperature of 57, Relative Humidity of 8 percent and a wind gust of 31 mph out of the east.**

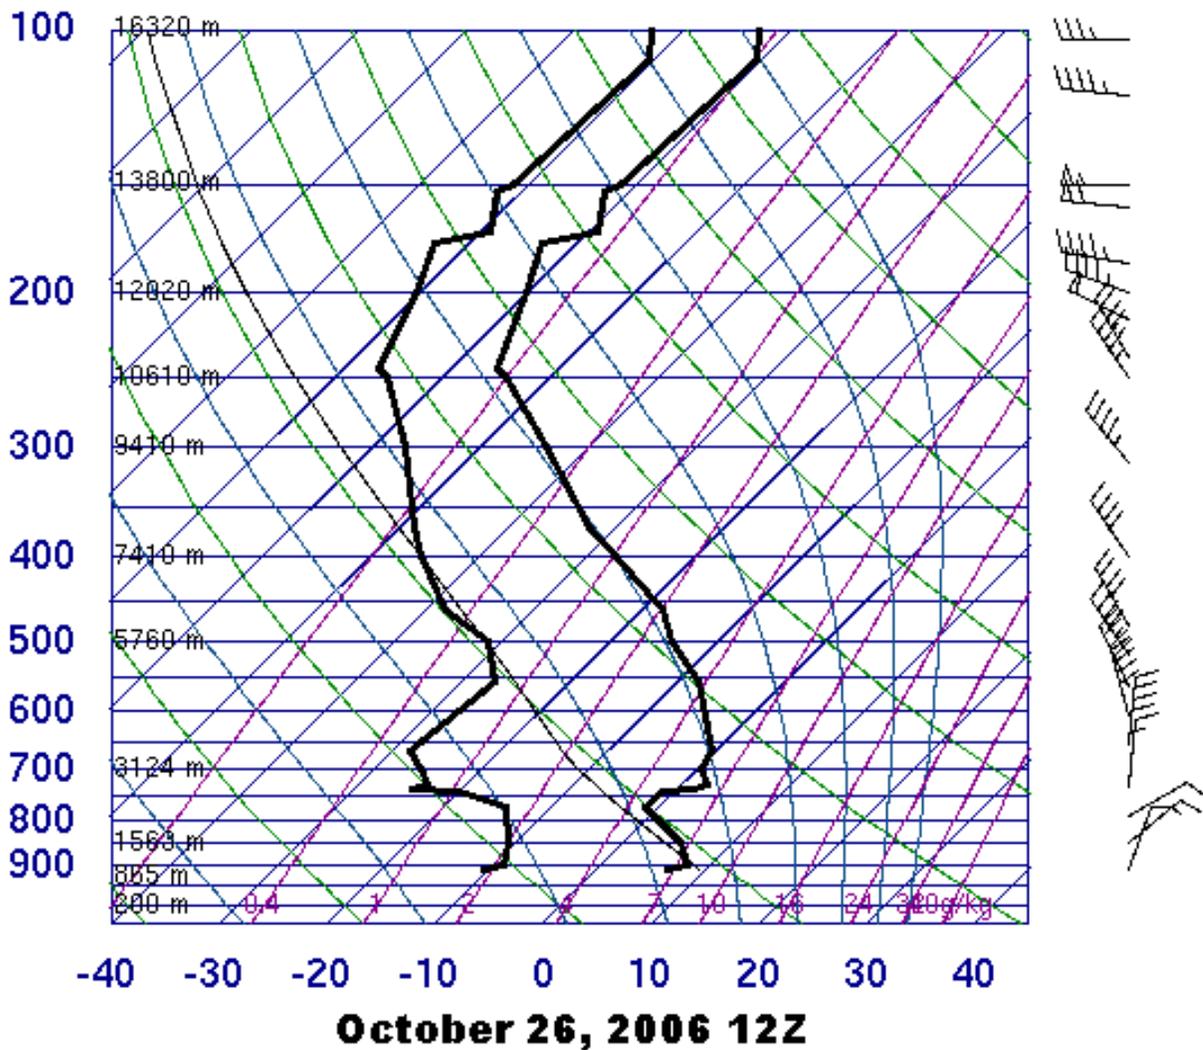
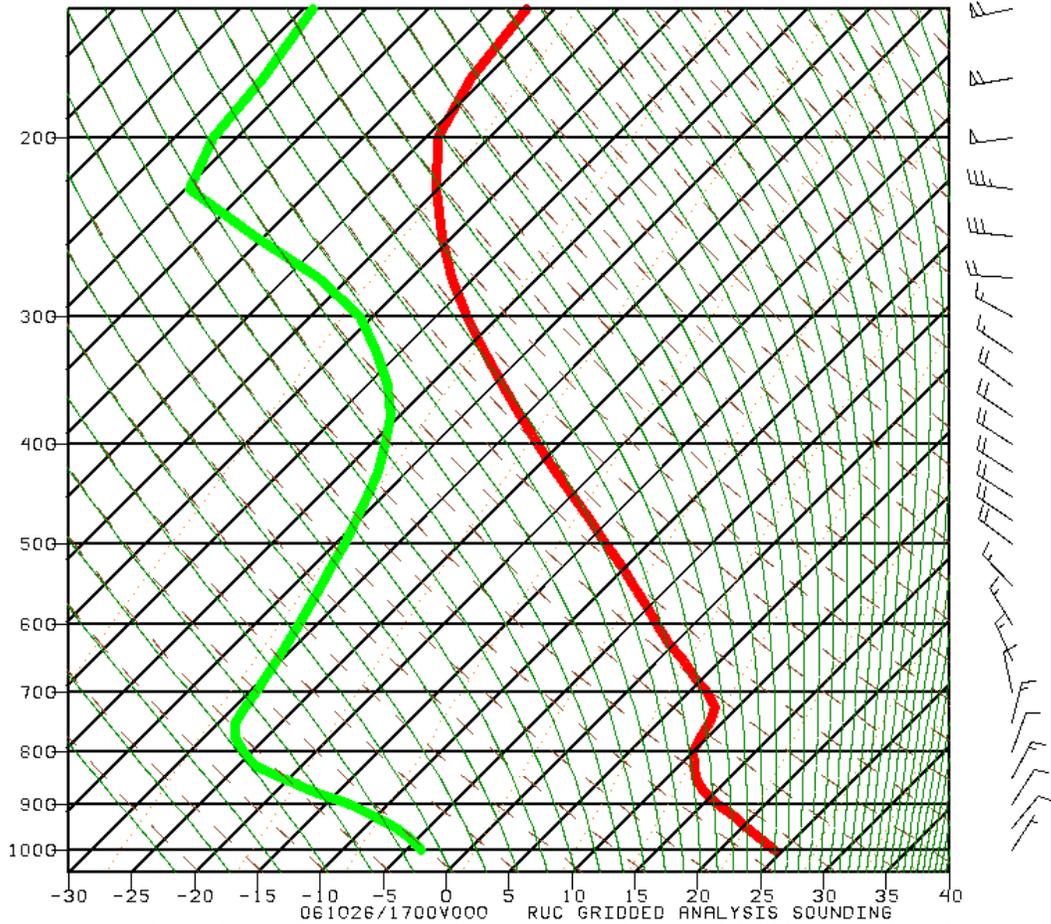
Fire Weather Figure 2 – Mercury, NV 12Z October 26 (7:00 am PDT Oct 26) observed sounding plotted on a Skew-T diagram. Height shown on far left is millibars with height above MSL in meters shown inside the chart on the left, temperature along the bottom is in degrees C with temperature lines slanted to the right. Solid thick black lines are temperature and dew point. Wind barbs on right show wind speed in knots.

**Fire Weather Figure 3 - RUC model sounding at 17Z on October 26, 2006 at a grid point close to the accident site plotted on a Skew-T diagram. Height shown on left in millibars, temperature along the bottom is shown in degrees C. Red line is the temperature, green line is the dew point. Wind barbs on right show wind speed in knots.**

The inversion over the area played a critical role in fire behavior. This includes channeling winds near the ground and preventing full ventilation of the fire under the stable atmospheric conditions present at this point in time as shown by the upper air soundings shown in Fire Weather Figures 2 and 3. The inversion was not at a constant height over the area. Over the San Gorgonio Pass area, the inversion height was between 5,000 and 6,000 feet MSL. The height of this inversion was forecast by the RUC computer model, and the height was confirmed near this level through observations and photos taken of the smoke plume over the fire at approximately 9:00 am by the Air Operations Supervisor. The inversion height slopes upward over higher terrain, but it does not stay at a constant height above the terrain. Fire Weather Figure 4 displays how winds follow the contours of a sloping land surface under inversion conditions described above. The free air above the inversion is minimally affected by the terrain. However under the inversion, wind speeds will increase as the distance between the ground and inversion decrease. The winds will increase the greatest closest to the ground where the slope has the greatest steepness.

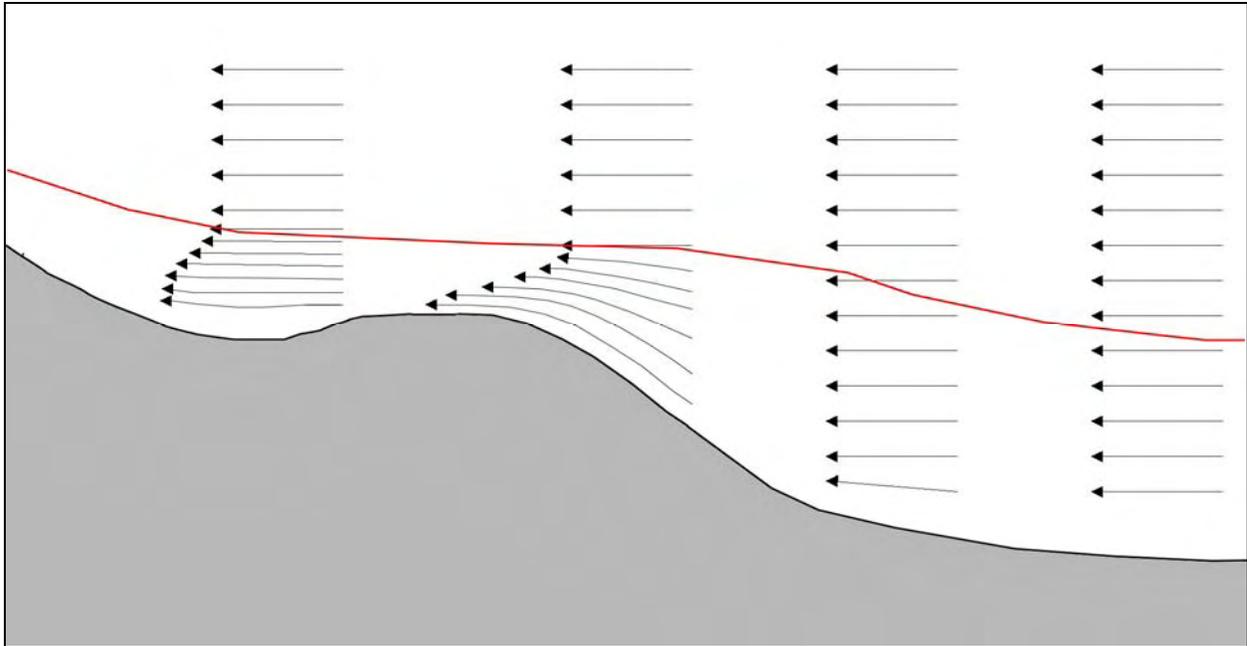
**Fire Weather Figure 4 - Wind flow up hill with a capping inversion. The length of the arrows indicates relative wind speed. The red line indicates the inversion height.**
